# 737 GRAPHITE COMPOSITE FLIGHT SPOILER FLIGHT SERVICE EVALUATION

SEVENTH ANNUAL REPORT  
MAY 1980 THROUGH APRIL 1981

Prepared under Contract NAS1-11668 by  
BOEING COMMERCIAL AIRPLANE COMPANY  
FEBRUARY 1982

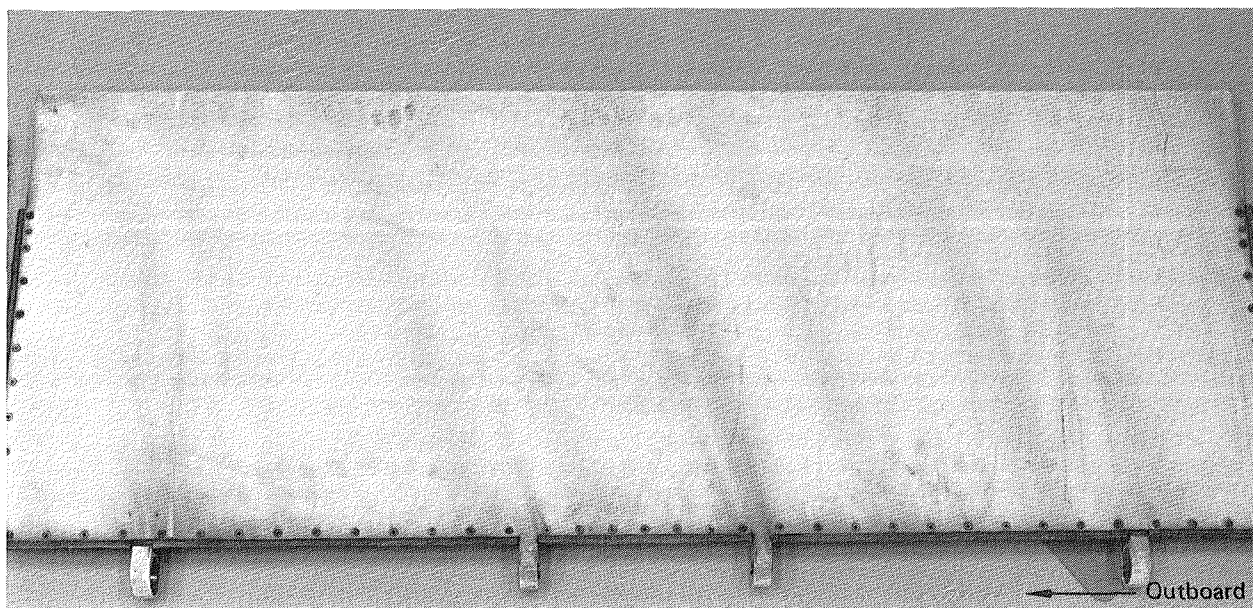
*Figure 2. Upper Surface of Spoiler S/N 0059 After 6 Years of Service*

Following selection for test, the units were photographed. Figures 2 and 3 show the upper and lower surface of spoiler S/N 0059. The discrepancies on this unit are shown in figures 4 through 6. Figure 4 shows some minor corrosion of one of the -23 aluminum doublers. Figure 5 shows an exfoliation corrosion blister at one spar to center hinge fitting splice, and figure 6 shows a similar exfoliation corrosion blister at the opposite side.

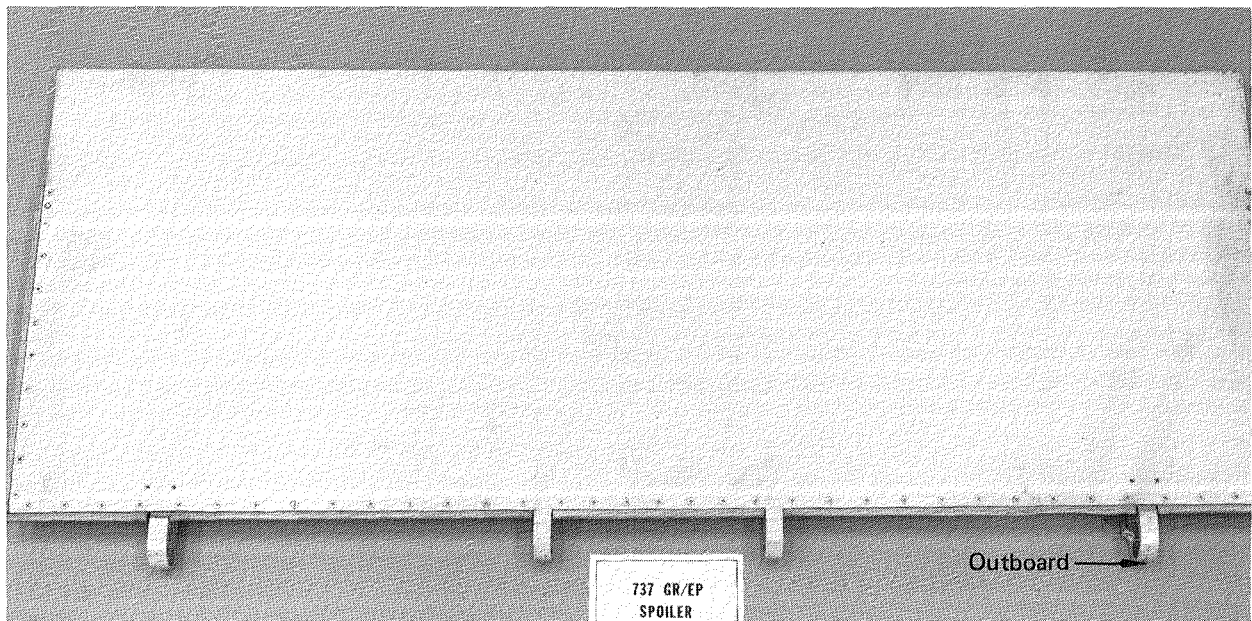
*Figure 7. Upper Surface of Spoiler S/N 0049 After 7 Years of Service*

Figures 7 and 8 are photographs of the upper and lower surfaces, respectively, of spoiler S/N 0049. Earlier minor doubler corrosion and flap rubbing had been dressed down and repainted by the airline. Discrepancies for this unit are shown in figures 9 through 12. Figure 9 shows an edge crack resulting from an exfoliation corrosion condition from the outboard spar to center hinge fitting splice. Figures 10 through 12 show the opposite splice in detail. The area had undergone a repair for exfoliation corrosion, but the problem redeveloped during additional service. The repair finish is relatively coarse, because this is not an aerodynamic surface. Figures 11 and 12 show in detail the corrosion blister and edge crack.

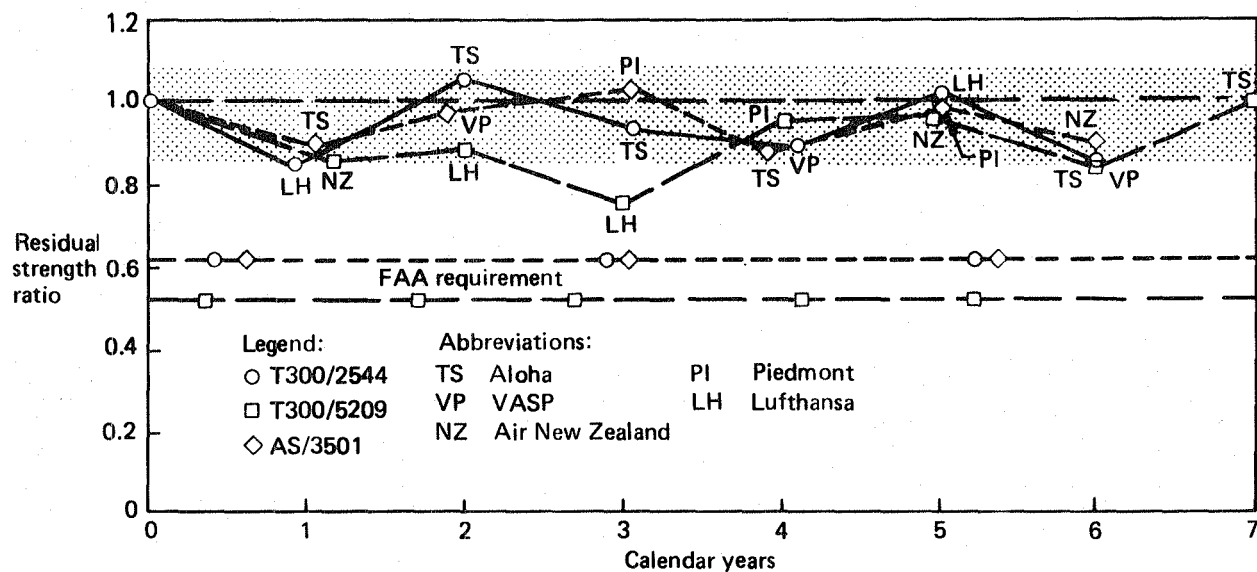
Figure 13. Summary of Residual Strength After Exposure

Table 4 gives data from all of the scheduled sixth-year removals and summarizes the strength and stiffness data from the two units that were statically tested. Table 5 gives similar data for the seventh-year removals. Figure 13 shows the residual static strength data accumulated to date. Each symbol represents one test of a particular spoiler dash number (i.e., type of skin material) after a predesignated period of time. Initials near the symbols indicate the airline from which the spoiler was removed. The data are shown as a residual strength ratio, where 1.0 is the original unexposed certification test value for each material system. The shaded area represents the scatterband for a total of 16 ultimate tests run on unexposed -2 units. Although limited to one production run of only one of the

three types of material, the band provides some idea of the minimum scatter that could be expected. The FAA ultimate load requirement for each material system is also shown in the figure. It can be seen that the three units tested after 6 years have residual strengths that are near the lower bound of the scatterband but well above the FAA requirement. The seventh-year unit had a residual strength only slightly lower than the unexposed baseline failure strength. Figures 14 and 15 are plots of the load-deflection data for these two panels. There is no discernible difference between baseline and residual stiffness for either unit.

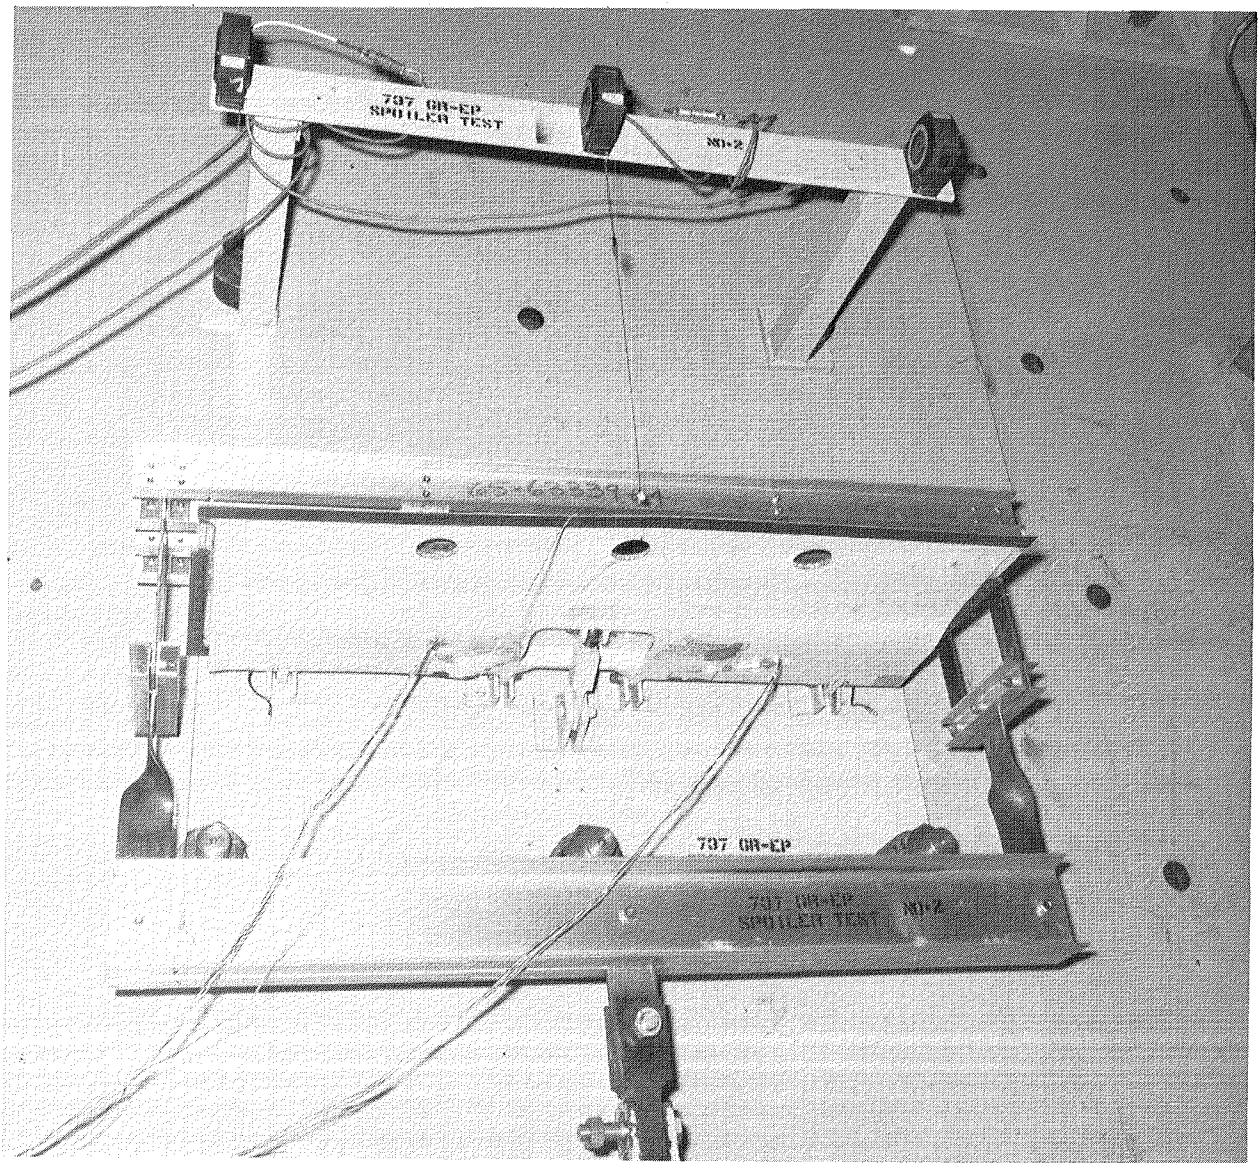
*Figure 16. Spoiler Residual Strength Test Setup*

Figure 16 shows the test setup. Load is applied to the upper surface through an evenner system and load pad scheme. The load is then reacted at the four hinge points and the actuator rod end.

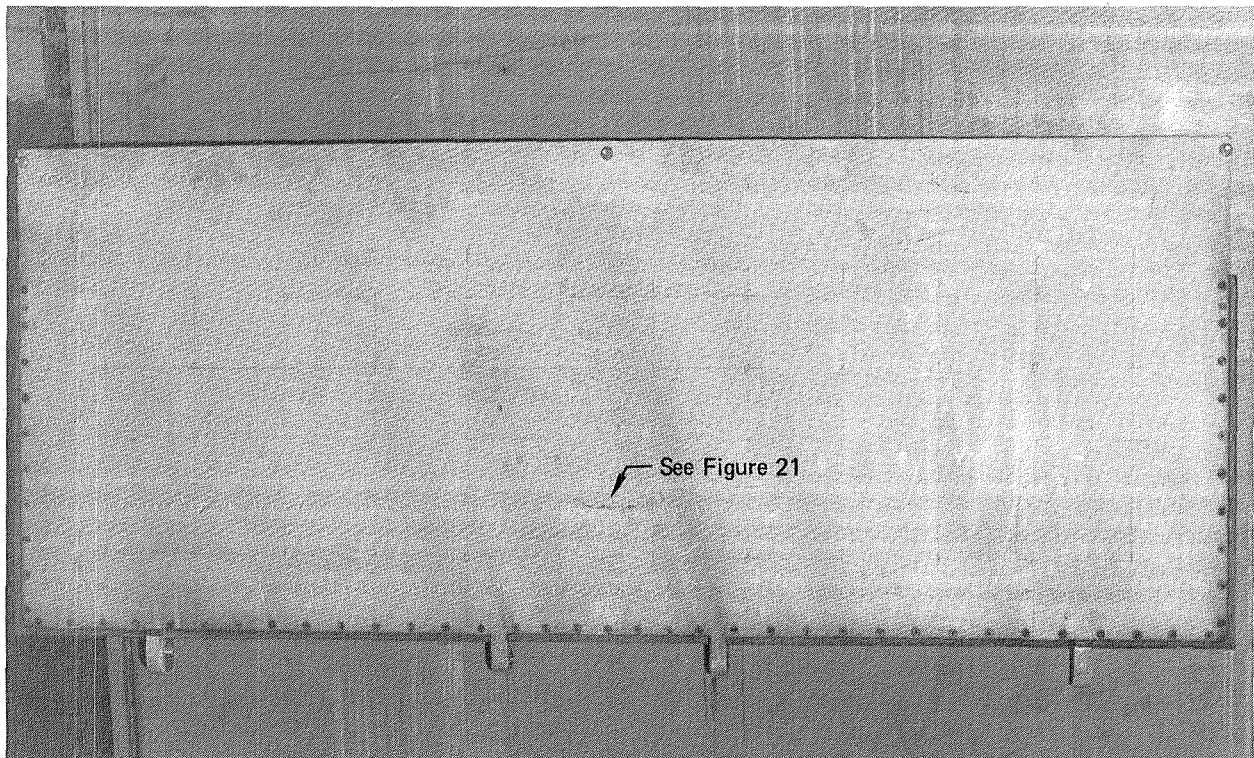
*Figure 17. Upper Surface of Spoiler S/N 0059 Following Residual Strength Test*

Figures 17 through 27 are photographs of the spoiler panels after testing. On both units, the exfoliation corrosion blisters locate the failure by allowing the compression-loaded lower skin to buckle at the blister location. As expected, these defects did not significantly reduce residual panel strength or stiffness.

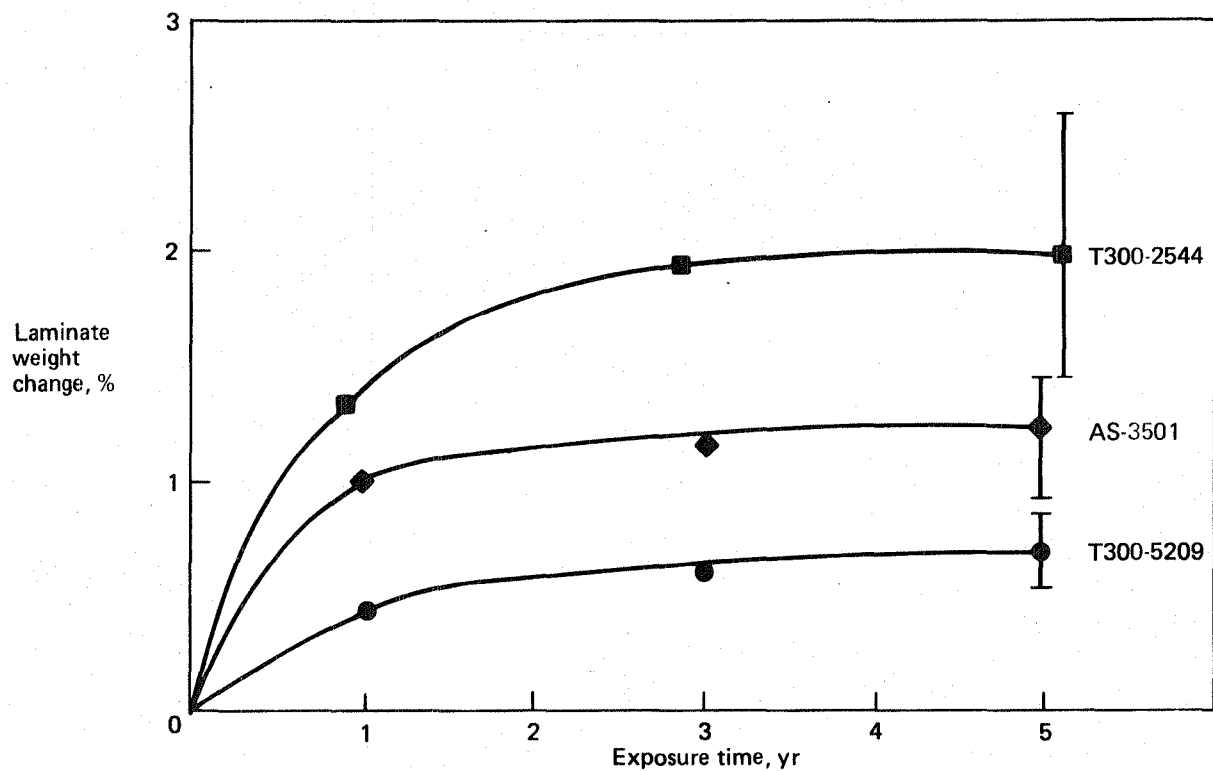
Figure 30. Moisture Pickup After Worldwide Exposures

The absorbed moisture content of the flexure specimens is calculated after the specimens are dried and weighed. The 7-year flexure specimens are not yet fully dried and, therefore, information on moisture content is not yet available. The moisture content data for 1-, 3-, and 5-year exposure periods, previously reported in reference 7, are shown in figure 30.

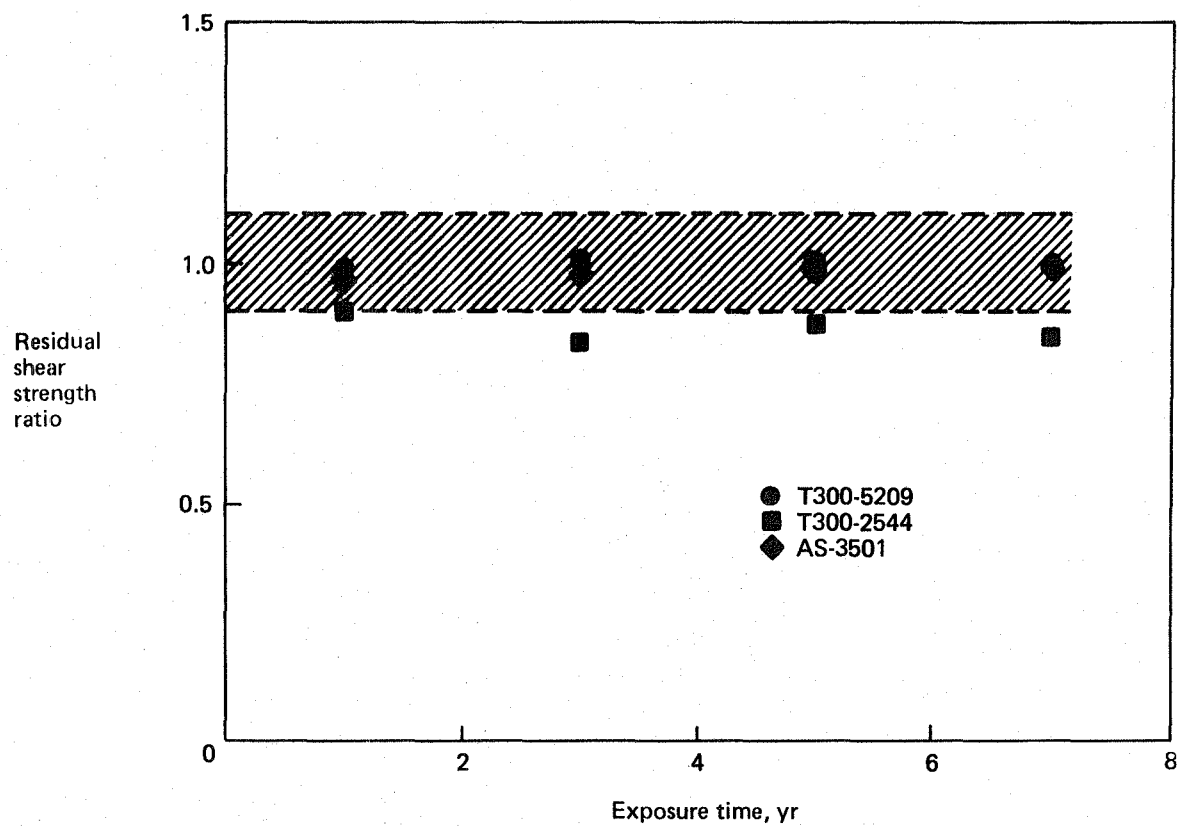
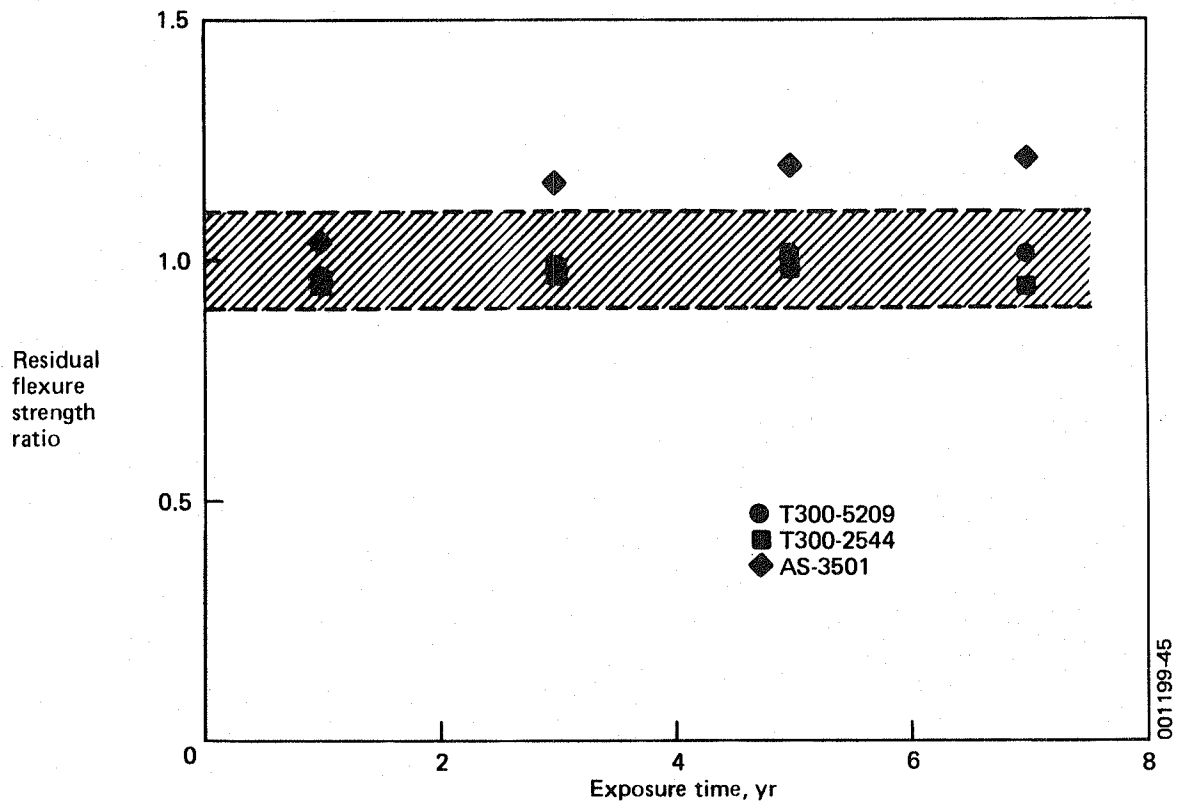
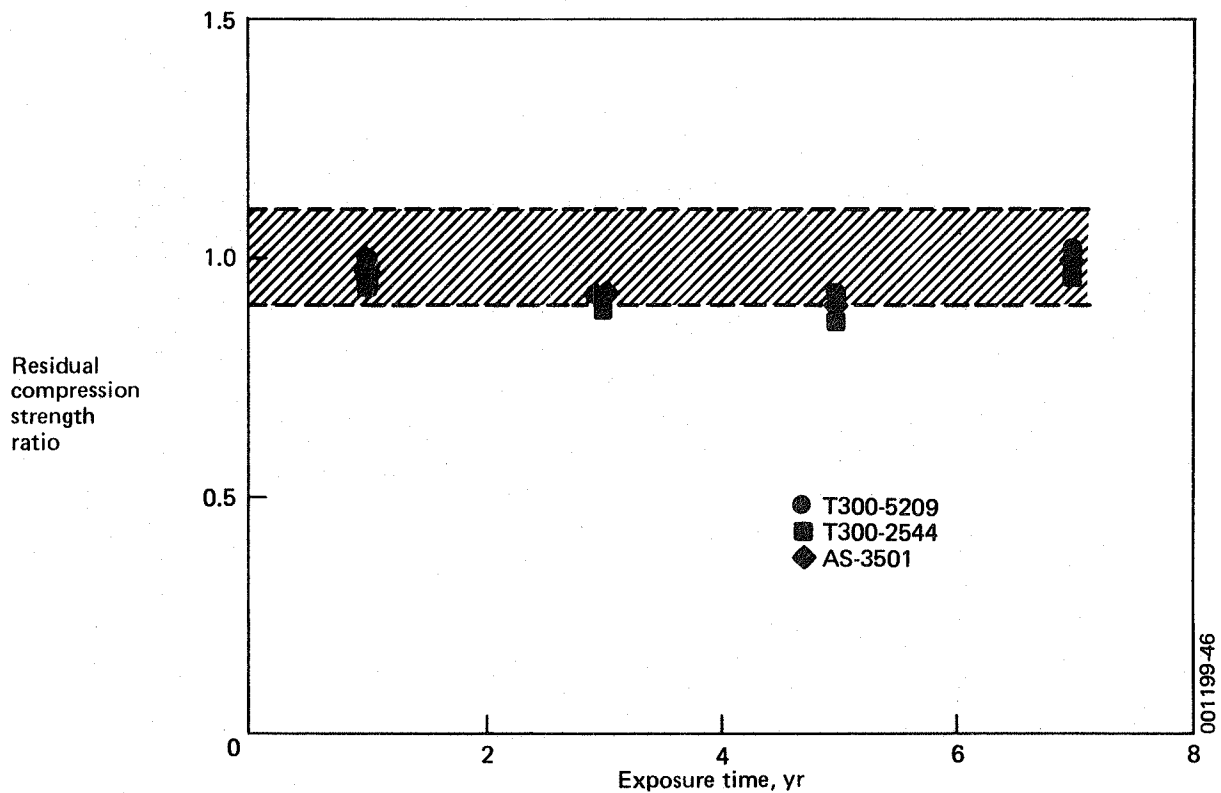
The average residual strength ratios for the shear, flexure, and compression specimens are plotted in figures 31, 32, and 33. These values represent a comparison of the average strength values for all six exposure sites with the average baseline strength value for that material system. A  $\pm 10\%$  bandwidth, which represents the strength scatter in the baseline specimens, is shown on each graph. The shear strength ratio values remain within the scatterband for all material systems except T300-2544, which continues to be slightly lower than baseline values. Flexure strength values are also within the scatterband except

for the AS-3501 material system, which has been consistently high (between 5% and 10% above the baseline) over the 3-, 5-, and 7-year exposure periods. The compression strength ratio has increased about 10% with 7 years of exposure for all material systems after a steady decline for the previous 5 years bringing the 7-year values very near the baseline strength values.
